Review

Biodiversity of cyanobacteria and green algae on monuments in the Mediterranean Basin: an overview

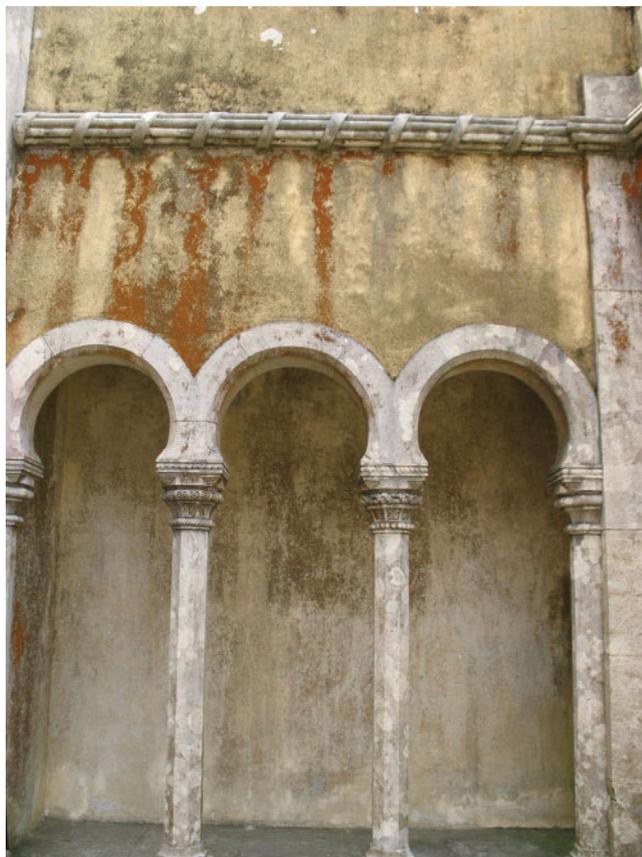
Fig. 1. Wall of the Palácio Nacional da Pena, Sintra (Portugal), showing extended colonization by *Trentepohlia* sp.

patinas and incrustations (Fig. 1) (Tomaselli *et al.*, 2000b). Identifying the micro-organisms involved in biodeterioration is one of the most important steps in the study of the microbial ecology of monumental stones. It can help us to understand the microbial biodiversity, the phases of colonization and the relationship among populations on the surfaces and between micro-organisms and substrata.

Klebsormidium, *Trebouxia* and *Trentepohlia* (Fig. 1) also showed a significant representation among the chlorophyte genera colonizing stone substrata in the Mediterranean Basin. The occurrence of *Trebouxia* and *Trentepohlia* indicates that these microalgae could be involved in the lichenization process leading to colonization by lichens. In fact, the genus *Trebouxia* occurs in approximately 20% of all lichens and has rarely been found free-living. Regarding endolithic growth of green algae, *Trentepohlia*, *Chlorella* and *Klebsormidium* were found growing under a black patina, probably a cryptoendolithic niche, in the Ordem de São Francisco Church, Portugal (Pereira de Oliveira, 2008; Pereira de Oliveira *et al.*, 2008). Cryptoendolithic growth of *Stichococcus bacillaris* was also observed in granite from the Cathedral of Toledo, Spain (Ortega-Calvo *et al.*, 1995).

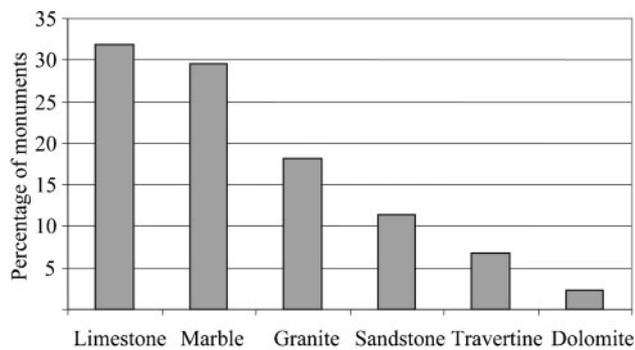
Fig. 2. Percentage of lithotypes present in the monuments, statues and historic buildings reported in this study.

Table 1 lists the monuments, statues and historic buildings reported in the literature covered in this review. Most of these works of art were built in limestone (32%) and marble (30%). Travertine (7%) and dolomite (2%) were less represented lithotypes (Fig. 2).

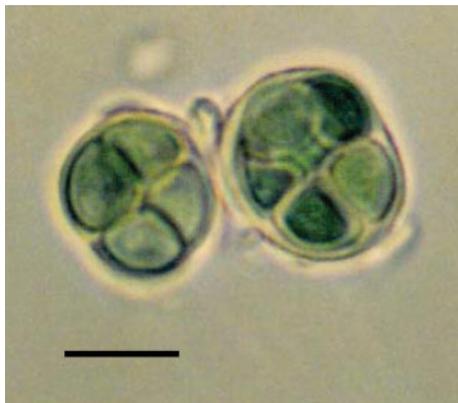
Fig. 3. *Gloeocapsa* sp. observed by optical microscopy. Scale bar, 20 μ m.

substratum. The data on cyanobacteria occurring on stone monuments and works of art is rather wide. A total of 96 taxa of cyanobacteria were found. The genus *Gloeocapsa* (Fig. 3) was the most widespread, occurring on 20 of the 45 monuments reported, on all substrata and represented by eight species. Cyanobacterial species from the genera *Phormidium* and *Chroococcus* were able to colonize five of the six stone substrata considered and they were represented by high species diversity: eight species of *Phormidium* and four species of *Chroococcus* were reported. *Chroococcus* species were detected colonizing 13 different monuments while *Phormidium* was found on 15 monuments. *Pleurocapsa* occurred on 13 monuments but only one species was identified, while the genus *Scytonema* occurred with five species and colonizing eight different monuments. Therefore, we can consider that *Gloeocapsa*, *Phormidium* and *Chroococcus* are the most common cyanobacterial genera on the monuments of the Mediterranean Basin. This is in accordance with Ortega-Calvo *et al.* (1995), who stated that the most common species found on monuments located in Europe, America and Asia belong to the genera *Gloeocapsa*, *Phormidium*, *Chroococcus* and *Microcoleus*. These genera are ubiquitous and therefore their presence is not strictly related to a specific lithic substratum or climate. Tomaselli *et al.* (2000b) also found that the data reported in the literature did not establish a clear relationship between organisms and the nature of the substratum. Nevertheless, these authors contend that *Phormidium tenue*, *Phormidium autumnale* and *Microcoleus vaginatus* prefer siliceous substrata.

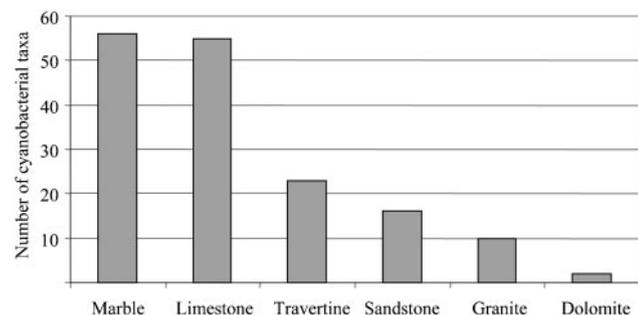
Fig. 4. Number of cyanobacterial taxa found on each lithotype.

Fig. 4 shows the number of cyanobacterial taxa present on each lithotype. According to the literature reviewed in this study, marble and limestone were colonized by about the same number of taxa (56 and 55, respectively). Travertine was a lithotype present only in 7% of the monuments reported but it was colonized by a considerable number of taxa (23). Granite was colonized by a very low number of different taxa (only 10) when compared with limestone or marble. According to Ortega-Calvo *et al.* (1995), granite, with a very low porosity and pH, is an unfavourable substratum for cyanobacteria. In fact, the colonization of stones is closely correlated with porosity, roughness, hygroscopicity and capillary water absorption, which strongly influence water availability for micro-organisms (Urzi & Realini, 1998; Prieto & Silva, 2005; Miller *et al.*, 2006).

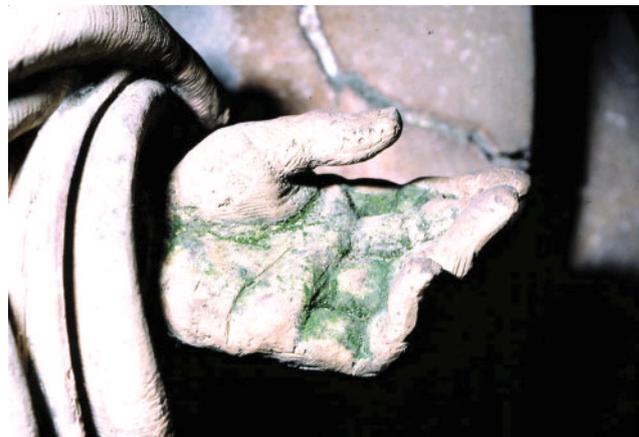
Fig. 5. *Klebsormidium flaccidum* biofilm on a terracotta statue, Cathedral of Seville.

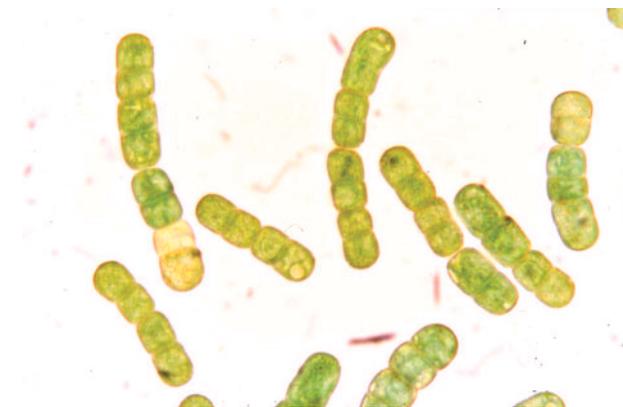
Fig. 6. Light micrograph of trichomes of *Borzia perikleii*, composed of 4–8 cells. Cells are 5–6 μ m wide and 5–11 μ m long.

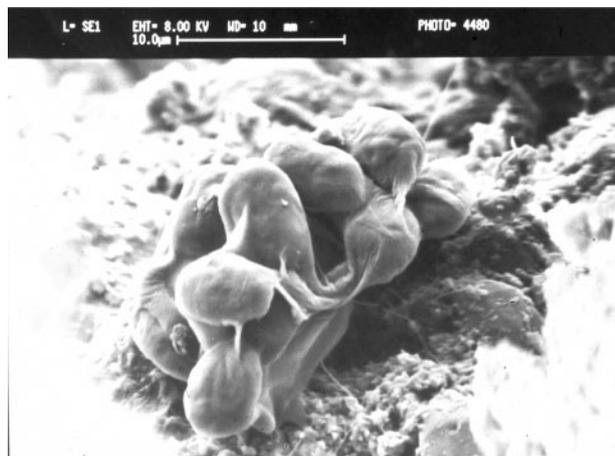
Fig. 7. SEM micrograph of a biofilm induced *in vitro* on a sandstone, showing *Gloeotheca* cells and sheath. Scale bar, 10 μm . Reproduced from Ariño (1996) with permission.

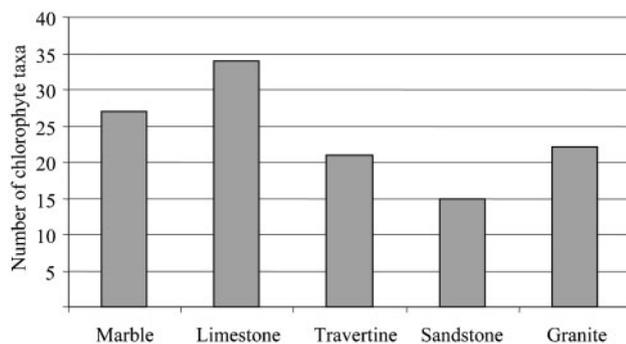
**Fig. 8.** Number of chlorophyte taxa found on each lithotype.

Fig. 8 shows the number of chlorophyta taxa present in each lithotype. Limestone was colonized by the highest number of taxa (34), followed by marble (27). Travertine and granite were colonized by about the same number of taxa (21 and 22, respectively), although the number of monuments built of travertine (7%) was considerably lower than the number made of granite (18%). From Table 3 we can see that *Oocystis*, *Cosmarium* and *Staurastrum* species appear almost exclusively on travertine. Nevertheless, the majority of the results suggest that green algae can colonize a wide variety of substrata and this is primarily related to the physical characteristics of the stone surface (porosity, roughness and permeability) and secondarily to the nature of the substratum. This is in accordance with Tiano *et al.* (1995). These authors carried out a laboratory experiment using two photosynthetic strains: a green alga (*Pleurococcus*) and a cyanobacterium (*Lyngbya*), inoculated on 12 different lithotypes exposed to constant climatic conditions. They demonstrated that the

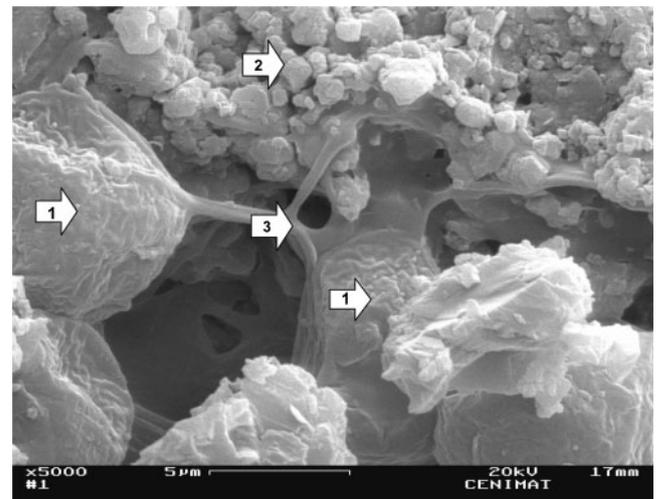
**Fig. 9.** SEM image showing green algae cells (arrow 1) adhered to a limestone surface (arrow 2) embedded in matrix of extracellular polymeric substances (arrow 3). Scale bar, 5 μ m.

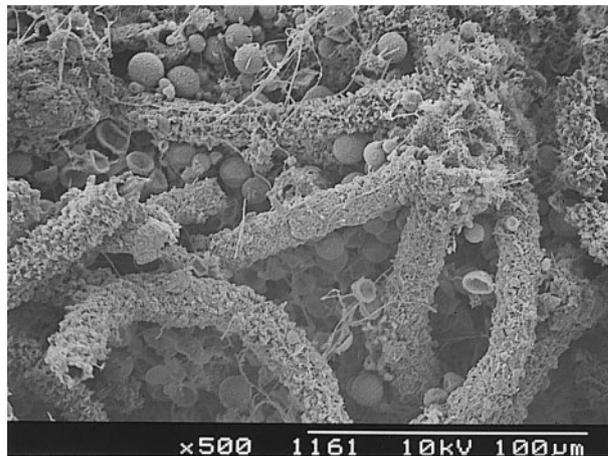
Fig. 10. SEM micrograph of *Scytonema julianum* mat. The calcified sheaths are composed of triradiate calcite crystals. Scale bar, 100 µm. Reproduced from Ortega-Calvo *et al.* (1995) with permission.

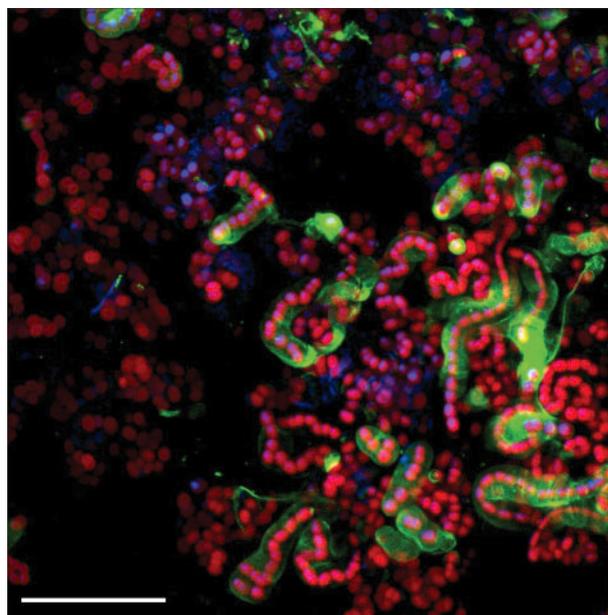
Fig. 11. Confocal microscope image of filaments of *Nostoc punctiforme* in the vegetative growth state (biofilm sample from Nerja Cave, Málaga, Spain). Pigment fluorescence is shown as red colour, polysaccharides labelled with Con-A-AlexaFluor 488 as green colour, and nucleic acids stained with Hoechst 33258 as blue colour. Scale bar, 50 µm.
